**UCSB Phelps Creek  
Bank Layback and Bridge  
Habitat Restoration Program  
2007-2012 Report,  
Year 5, Final Report**

**Prepared by  
Cheadle Center for Biodiversity and Ecological Restoration  
<http://ccber.lifesci.ucsb.edu>  
University of California, Santa Barbara  
October 2012**

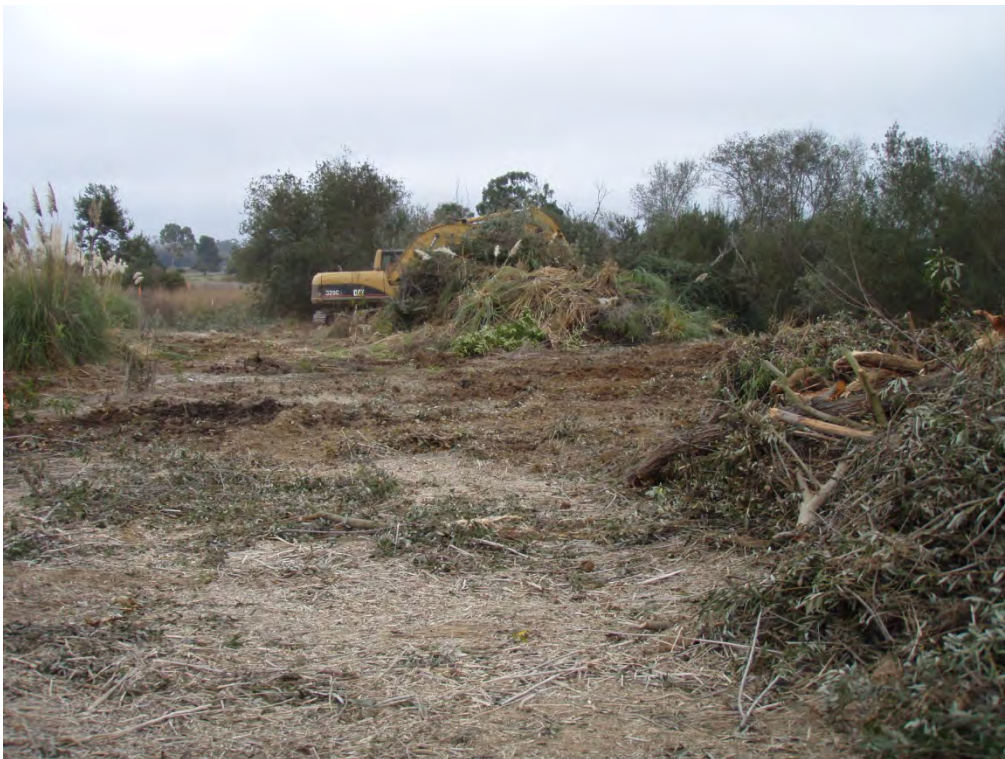
**Figure 11i: View from bridge October 2012**

The willow stakes installed at the inception of the project have enjoyed tremendous success as evidenced by the 2012 view from bridge (Figure 11i). As in the previous year, no planting or irrigation was performed at the project site, and the bulk of the time spent on the site (200+ hours) involved the hand removal of exotic species, particularly, bristly ox-tongue (*Picris echioides*). The rest of the time working on the site involved using herbicide in an attempt to eliminate remnant populations of Bermuda grass (*Cynodon dactylon*) and birdfoot deervetch (*Lotus corniculatus*). The creek vegetation continues to recover from the dredging done by Santa Barbara County Flood Control District last year, but has not yet reached the same size and breadth it reached before the dredging. There remains little to no erosion on the site, and the creek layback remains structurally intact. The adjacent North Parcel restoration project is now almost complete, so the input of exotic seed from the previously weedy area should now be mostly eliminated. Finally, the trees that were planted in the overflow area have now become well established and the overflow island is dominated by native cover.
